RESTORATION OF THE SACRISTY VAULT OF THE CHURCH OF SANTA MARIA DI MONTESANTO, PIAZZA DEL POPOLO IN ROME

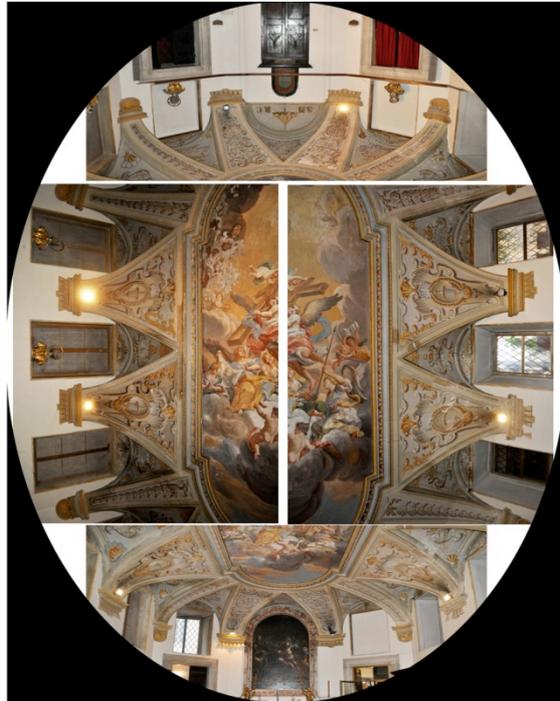
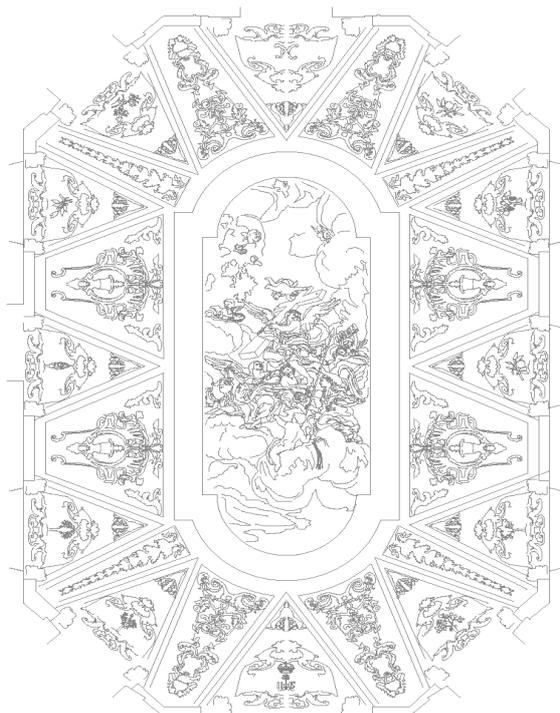
The painting depicting a *Gloria of angels with instruments of the Passion* on the vault of the sacristy in the church of Santa Maria di Montesanto is in poor condition.

Numerous pigmented surfaces are partly detached from the base and are in danger of falling off, while medium-sized and large gaps evidence the deterioration of the work in terms of both the architectural and the figurative iconography.

The deterioration also affects the moulded stucco surfaces, which are visibly abraded and in the worst cases lost.

The aim of the restoration project is to halt the painted surface and its preparation with acrylic adhesives which are compatible with the work. This operation should ensure that the surfaces on the verge of falling off be fixed and made level to the vault again, so that the solid paint film can subsequently be cleaned by removing dust, grease and smoke and the organic and other substances which have taken root on the surfaces in the past. The cleaning will be carried out both *dry* with soft high-density rubbers and *chemically* with non-polar solvents so as to not weaken the tempera painting.

The superficial abrasions and the gaps will be restored with a binder composed of suitably smoothed and treated air mortar which will constitute the base for the restoration.

The touch-up painting will be carried out according to a cultural heritage code which calls for very limited painting restoration, to be decided each time by mutual agreement with the relative government department.
